ASTM E84-23d Fire Test Report

Issued to **Stabilit America, Inc**

Product ID **Marlite Artizan FRP Item Code 209359**

RTL0871-1

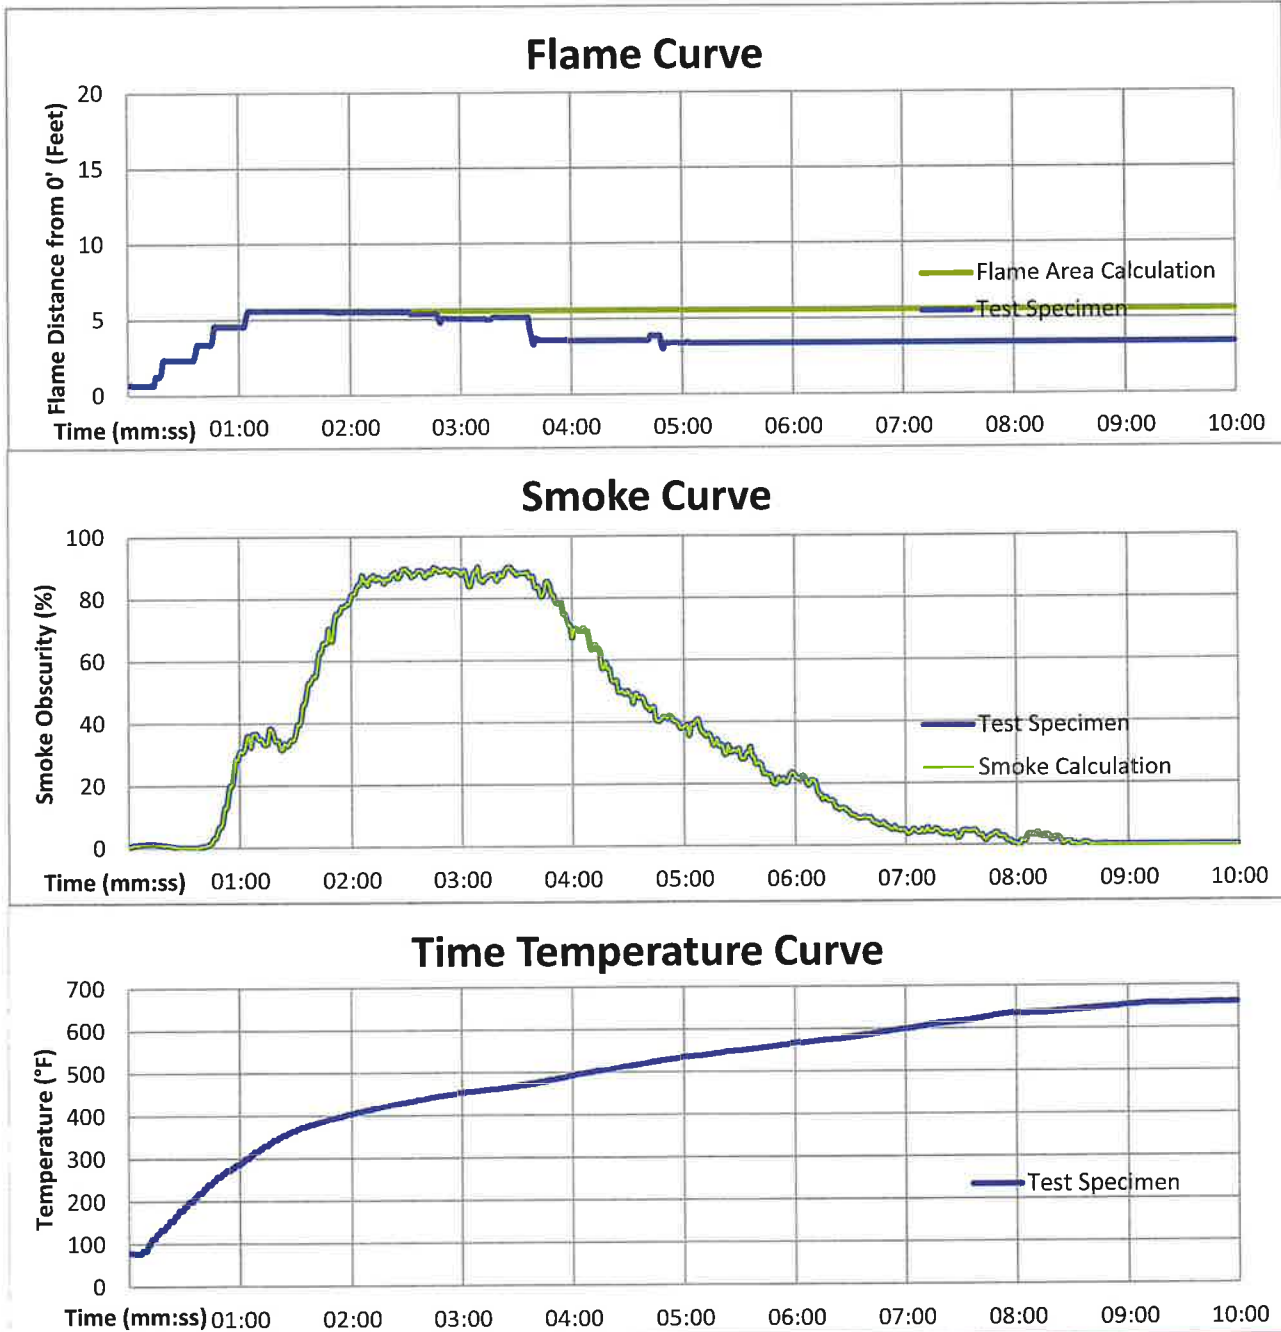
Appendix A - Test Data

Total Area (FT/Min)	52.6
FSI (unrounded)	27.1
SDI (unrounded)	345.3
Time of Ignition	00:37
Max Flame Distance 10-min Test (ft)	5.6
Time at Max Flame Distance 10-min (mm:ss)	01:05
Maximum Smoke Obscurity (%)	90
Time at Maximum Smoke (mm:ss)	03:09
Maximum Temperature Exposed Thermocouple (°F)	660
Time at Maximum Temperature (mm:ss)	09:58
Total Duration of Test	10:00

*See Appendix A for test data sheets.

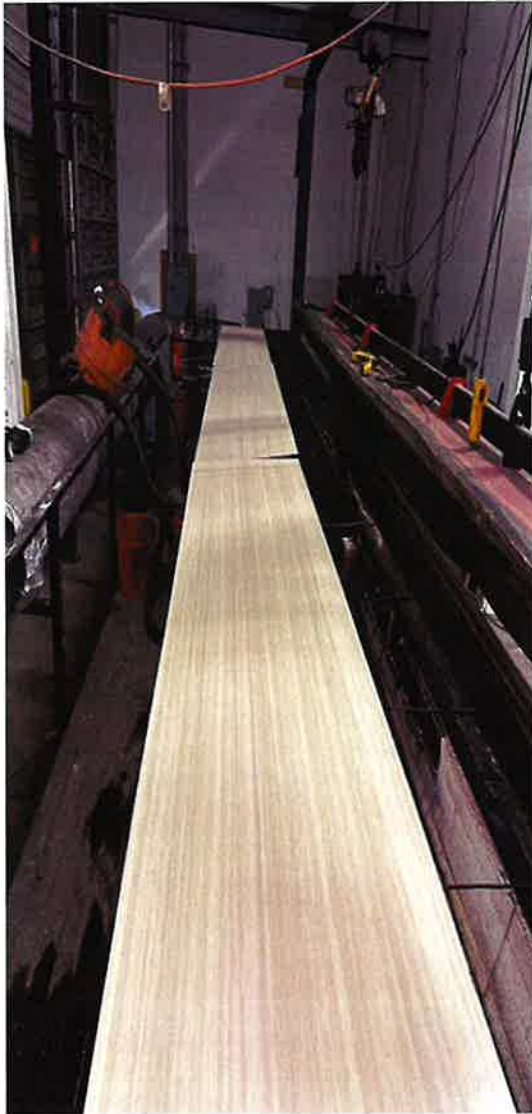
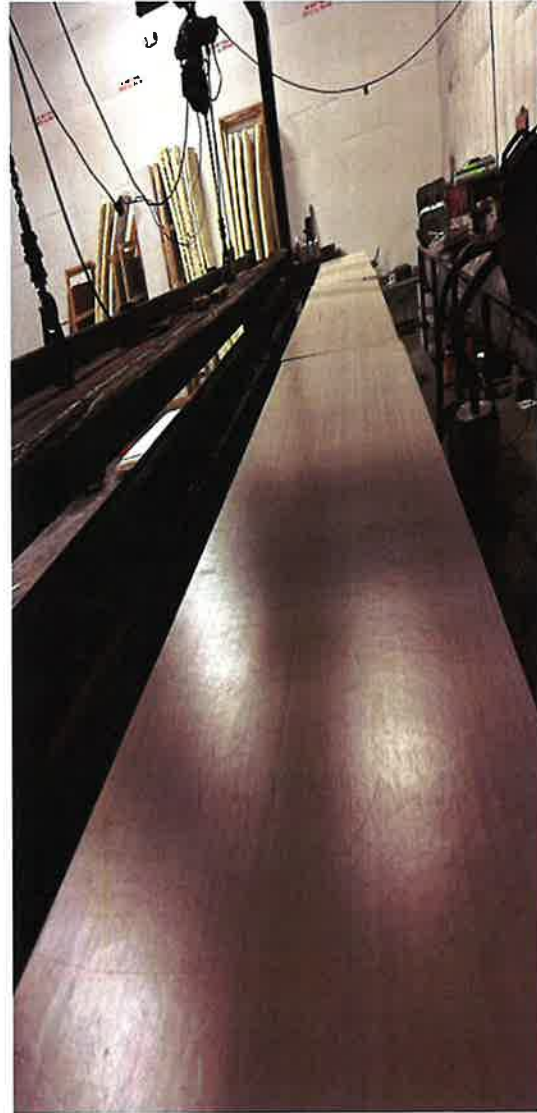
Photograph No. 1: Test specimen prior to testing showing the entire 24-foot test specimen from the fire exposure chamber's burner end (left), and vent end (right).

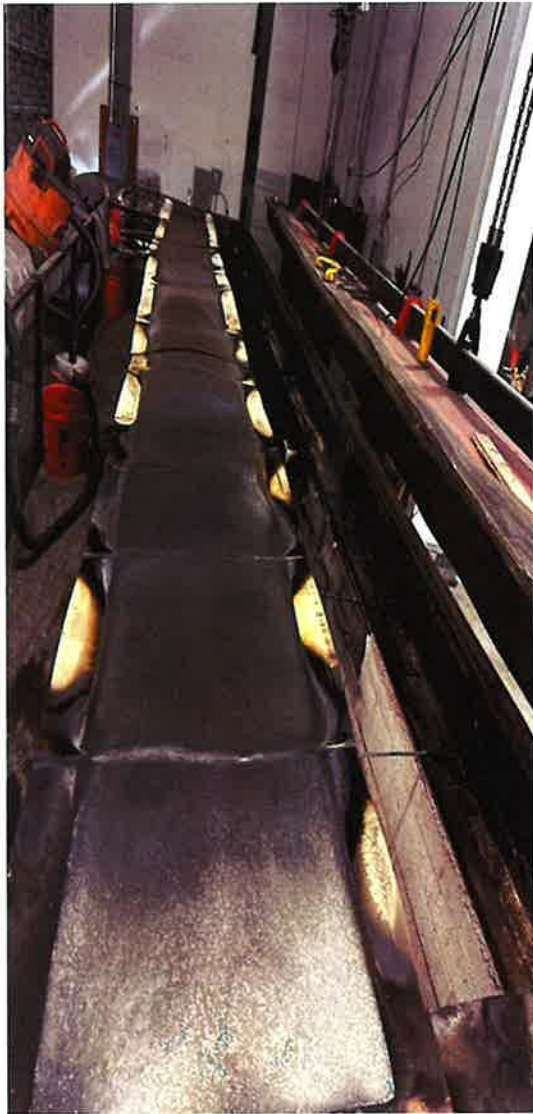
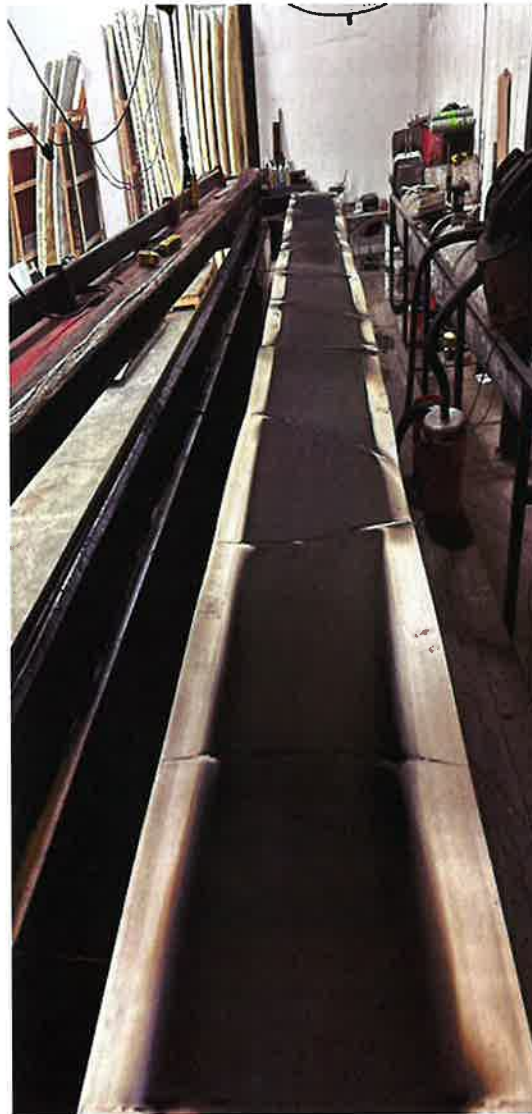
Photograph No. 2: Test specimen from the test chambers burner end (left), and vent end (right) showing the post 10-minute test sample condition immediately after removal from the test chamber.

Discoloration at 11-seconds. Material ignited at 37-seconds. Bubbling t 48-seconds. Charring at 1-minute and 19-seconds. Floor Burning at 6-minutes and 31-seconds. The test specimen remained in place for the duration of the test. After glow and Afterburn at the conclusion of the test.
